ACOUSTICAL REPORT

September 19, 2011

Re: Office of Cable Television Relocation to 1899 9th Street, NE
Acoustical Privacy

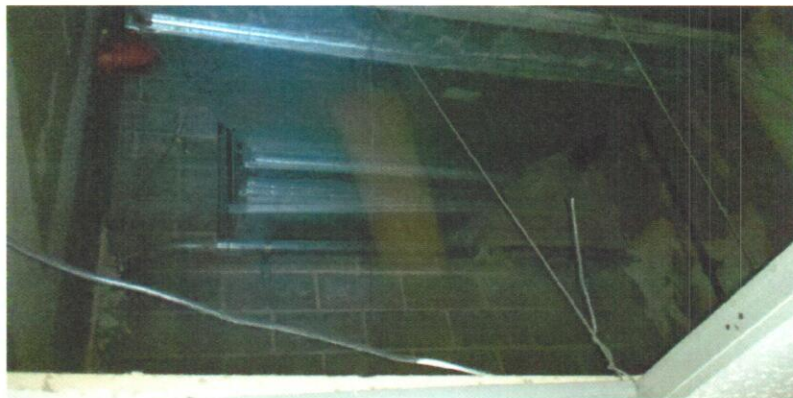
From EMG power to large studio A the measured rating was Noise Isolation Class (NIC) 55. The NIC rating is essentially a field version of the more familiar Sound Transmission Class (STC) rating, but the NIC rating is not adjusted to account for the size of the wall or the amount of sound absorbing materials present as is the STC rating. This test was not a true test of the wall, since so much of the sound was leaking through the corridor to the large studio A double doors. During this test we noted that there is a large duct passing over the ceiling of EMG power to the studio which penetrates the concrete block wall of the studio (see Figure 1).

Figure 1. Photo of Duct over EMG Power

- From EMG power to large studio A we recommend packing back insulation between the duct and the concrete block to better seal it.
- From electrical 043 and 044 to each of the studios we recommend sealing all wall penetrations on both the electrical room side and the studio A/B sides to be air tight. Use acoustical sealant for gaps up to 3/8" wide, and tightly pack fiberglass batt insulation into the gap if it is 1/2" or more wide.

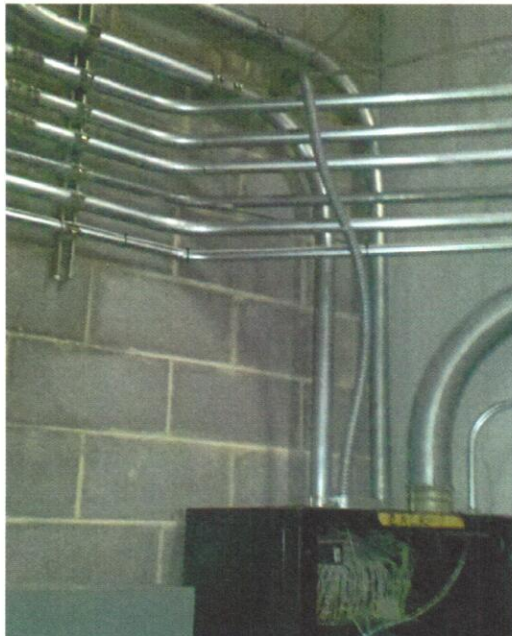
From electrical 044 to large studio A the rating was only NIC 58, and from electrical 043 to large studio A the rating was only NIC 52. Likewise, from electrical 044 to small studio B the rating was only NIC 55, and from electrical 043 to small studio the rating was only NIC 48. In each of these cases there was significant sound leaking through wall penetrations. We could see one such hole roughly 10 feet above the floor (see the top of Figure 2), and we could hear leaks roughly 10 and 20 feet above the floor in each case.

Figure 2. Photo of One Representative Wall Penetration in Electrical Room

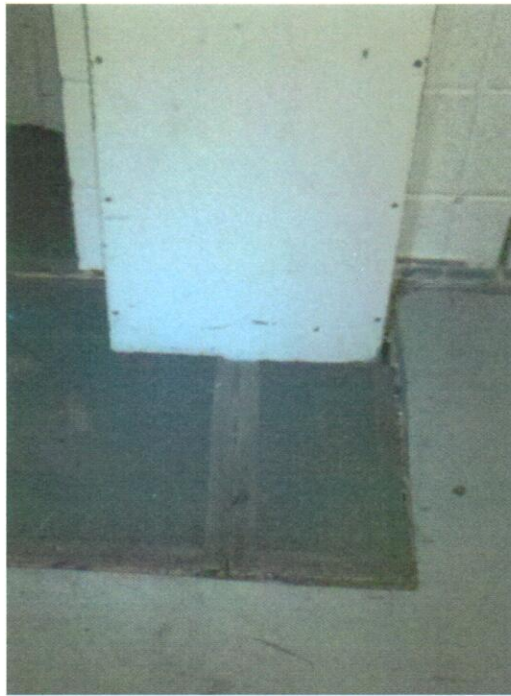
From Audio B to small studio B the rating was only NIC 58. Likewise from Audio A to large studio A the rating was only NIC 54. In each case, there is a significant leak at the raised floor / walker duct under the wall (see Figures 3 and 4).

Figure 3. Raised Floor into Small Studio B

- From Audio B to small studio B and from Audio A to large studio A at the raised floor / walker ducts, sound is leaking to/from the two studios. We noticed that the built-out areas shown in Figures 3 and 4 do not show up on the architectural floor plan. We recommend adding an additional layer of 5/8" gypsum board to the three sides of these built-out areas shown in Figures 3 and 4 for the full height. In addition, use neoprene gaskets such as Pemko S88 on all four sides for the removable plywood access panels on each end, and pack at least 3 feet of batt insulation into the wall and floor on each end of these paths.

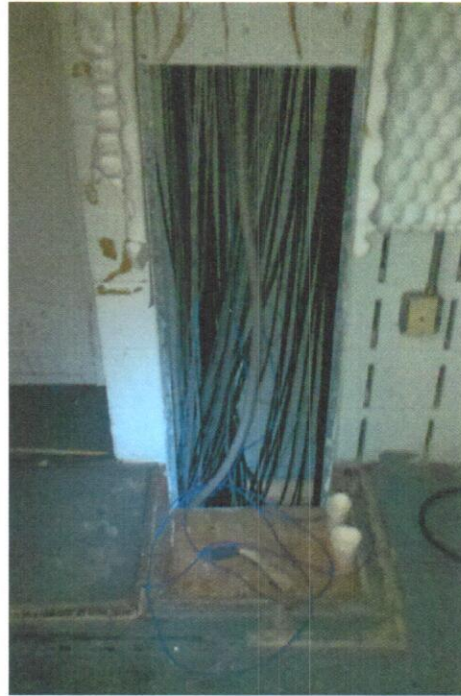
Figure 4. Raised Floor into Small Studio A

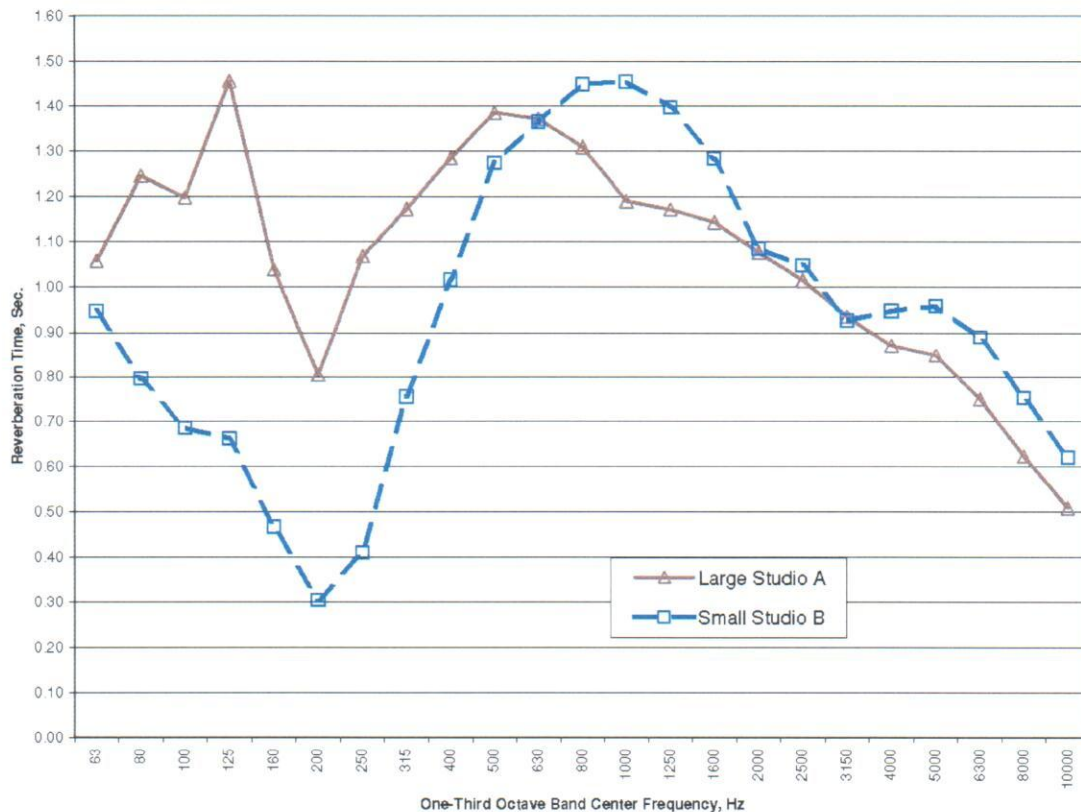
The reverberation time is the amount of time it takes a loud sound to fade after it ends and become inaudible. The reverberation time is typically measured or predicted in various frequency bands either one octave wide or one-third of an octave wide. We measured reverberation times in one-third octave bands at various locations in each studio and the averages are presented in Figure 1.

seconds, respectively (these were taken from the Master Handbook of Acoustics). These goals are most important at frequencies of 250 Hz and higher – slightly longer times are fine at lower frequencies since speech sound is less significant at those frequencies. It can be seen from Figure 1 that the reverberation times in the large Studio A are far above the goal of 0.7 seconds at frequencies of 250 to 3150 Hz, and the times in the small Studio B are far above the goal of 0.5 seconds at frequencies of 315 to 8000 Hz.

Figure 1. Measured Average Reverberation Times

In order to reduce reverberation times we recommend changing some room finishes. In order to predict the effects of changes to the finishes, we modeled the acoustics of the studios in a computer spreadsheet which predicts reverberation times as a function of the areas and assumed octave band sound absorption coefficients of all of the room finish materials. In setting up this spreadsheet it is necessary to tweak the assumed sound absorption coefficients (relative to those claimed by the product manufacturers or published in various locations) in order to get the output of the spreadsheet to exactly match the measured reverberation times. After an initial pass at setting up the spreadsheet the predicted reverberation times were 3 to 28% off in each frequency band in the large studio and 7 to 60% off in the small studio. In order to compensate, it was necessary to make relatively significant changes to the assumed finish acoustical properties. We believe the finishes are not performing as well as they should (or once did). We assumed that the slotted SoundBlox is performing far worse than we originally thought at high frequencies, the roof insulation is performing somewhat worse than we originally

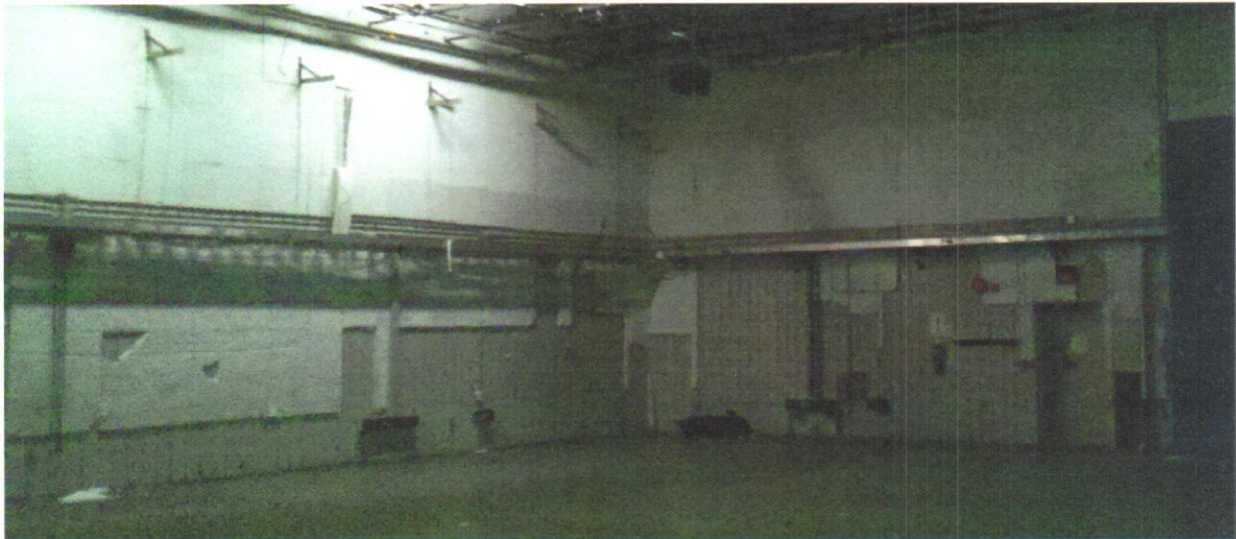
2. Since the Sonex panels are so spotty in coverage (see Figure 2), and it is not acceptable acoustically to paint them, we assumed that they would be removed entirely.

Figure 2. Photo Showing Uneven Coverage of Sonex Panels

3. New 2" thick fabric-faced fiberglass panels would be added with an area as needed to reach the desired reverberation times. We predict that this would be achieved if the new acoustical panels are used on all four walls in a 24-foot tall band (i.e., approximately 6700 sf) for the large studio A and in a 15-foot tall band (i.e., approximately 2350 sf) for the small studio B. If these areas are too costly for the budget, use as much area as possible. The cost would be lower using panels which have the fabric adhered to the fiberglass as opposed to stretched fabric panels.

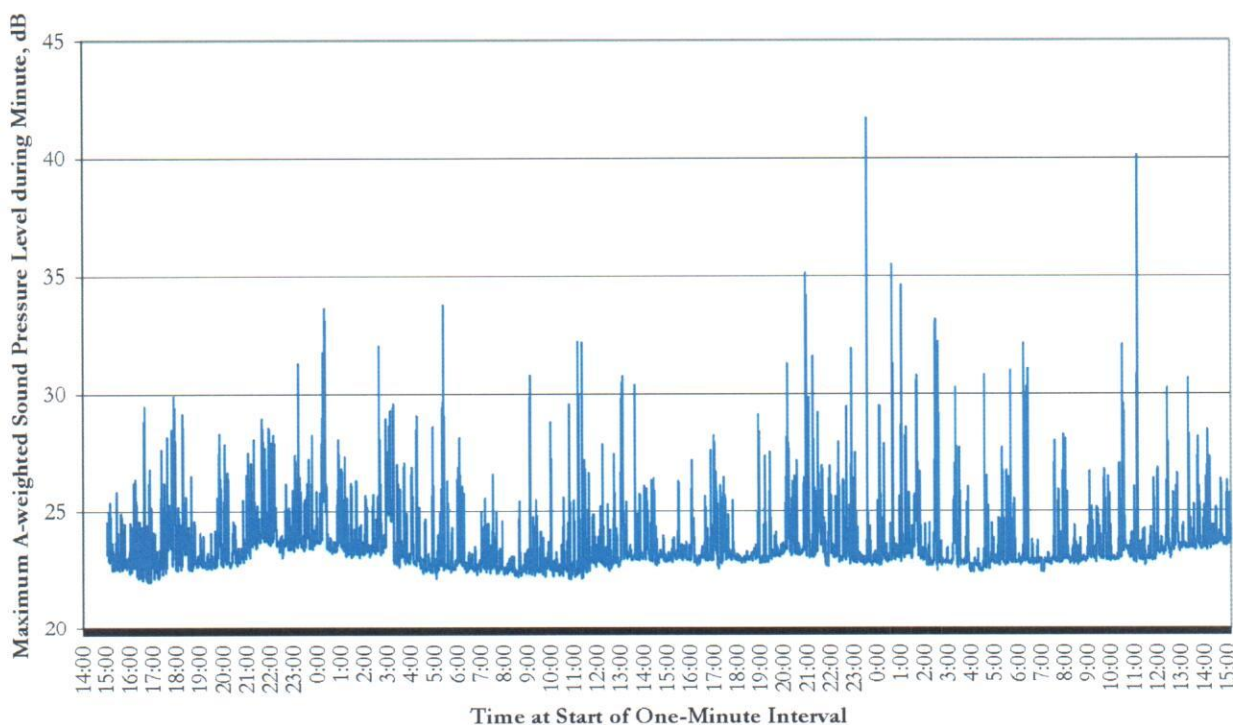
Figure 1 presents the maximum A-weighted sound levels each minute in small studio B, and Figure 2 presents the maximum NC rating each minute in small studio B.

Figure 1. Maximum A-weighted Sound Levels in Small Studio B

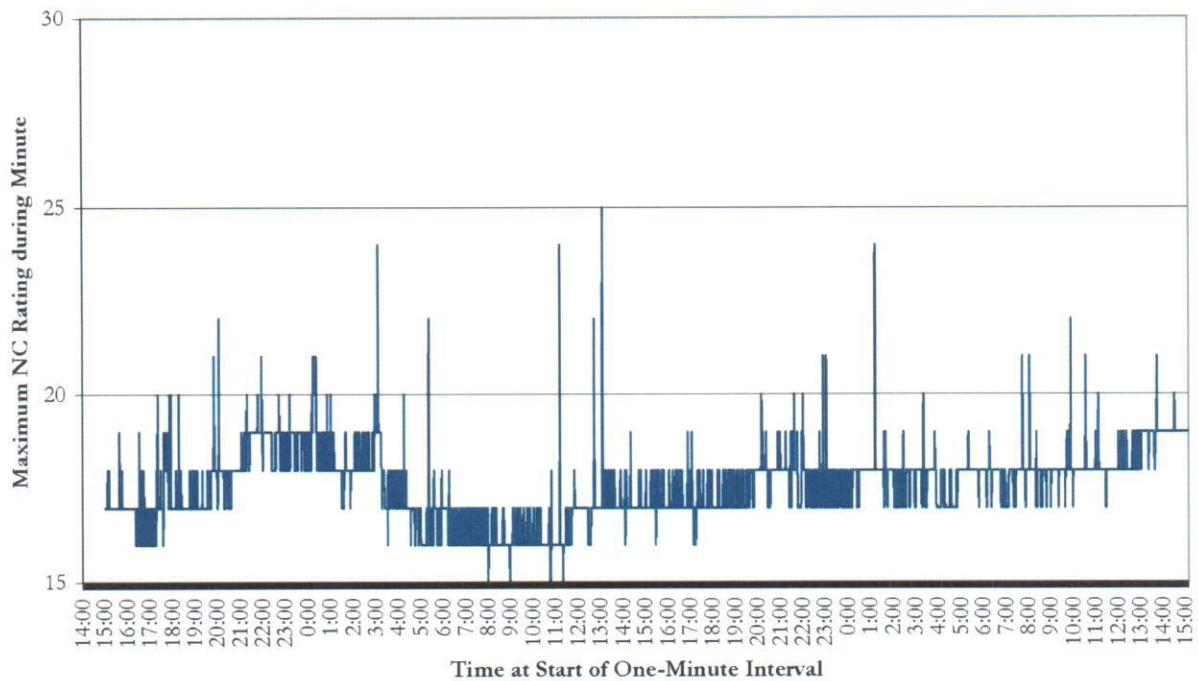
There is no universally-used goal for site noise reception indoors. However, one reasonable goal is NC 20. During the two days of data indoors (2,888 minutes), the rating exceeded NC 20 at least one second during 22 one-minute intervals, and exceeded NC 21 at least one second during 8 one-minute intervals. This shows that site noise exceeds the goal relatively infrequently.

Sound is certainly not entering the studios through the walls. It is likely that the main sound transmission path is the roof. It is also possible that sound is entering through exterior windows and doors into corridors and then through the studio doors. If it were desired to reduce sound levels, it likely would be necessary to install a noise control ceiling such as gypsum board held 8 to 12 inches or more below the roof. [If the doors happen to be the weakest link, changing the door seals would also help.] Installing such a noise control ceiling likely is not warranted given the measured noise levels.

Figure 2. Maximum NC Ratings in Small Studio B
